Manhole Inspection Summary

Manhole # S31Q1_012MH

Location Address: **762 Deaconhill Ct**

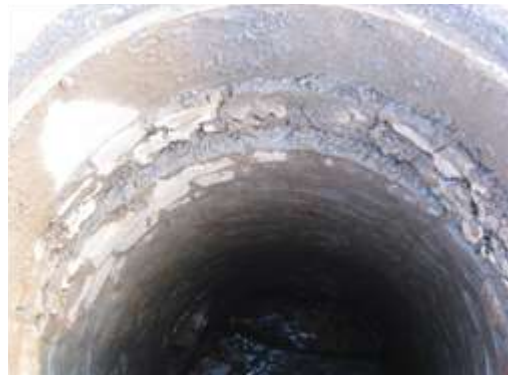
Defect 1

Offset: **1** (in.)

Infiltration: ☐ None ☒ **Joint** ☐ Cracks ☒ **Mortar** ☐ Roots ☐ Wall

Frame offset/chimney

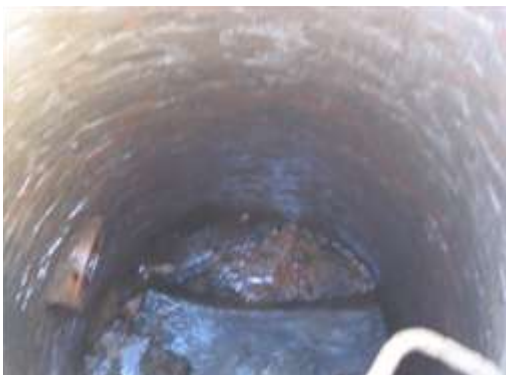
Defect 2

Infiltration mortar and joint

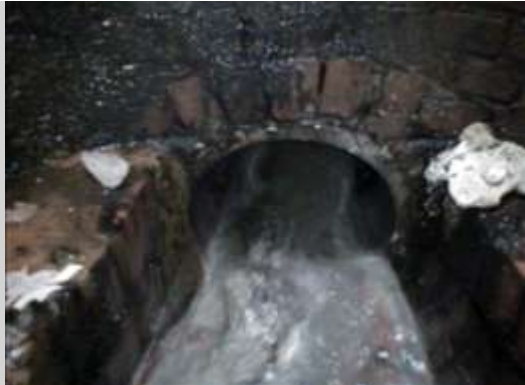
12 O'Clock Outflow

12 in. Circular Gravity Sewer
Pipe Out @ 12 O'Clock

Pipe Height: **15.6** (in.) Rod and Bar (Angled)
Pipe Material: **Clay** ☐ Pipe Lined
Invert Depth: **13.72** (ft.) Flow Characteristics: **Fast**
Deposits: ☒ None ☐ Mud ☐ Sludge ☐ Debris ☐ Grease
Silt Depth: (in.) Deposits Extent:
Infiltration: **None** Pipe Seal Cond: **Sound**

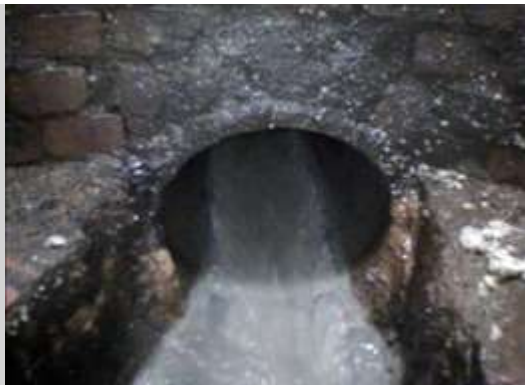
5 O'Clock Inflow

12 in. Circular Gravity Sewer
Pipe In @ 5 O'Clock

Pipe Height: **14.4** (in.) Rod and Bar (Angled)
Pipe Material: **Clay** ☐ Pipe Lined
Invert Depth: **13.47** (ft.) Flow Characteristics: **Fast**
Deposits: ☒ None ☐ Mud ☐ Sludge ☐ Debris ☐ Grease
Silt Depth: (in.) Deposits Extent:
Infiltration: **None** Pipe Seal Cond: **Sound**

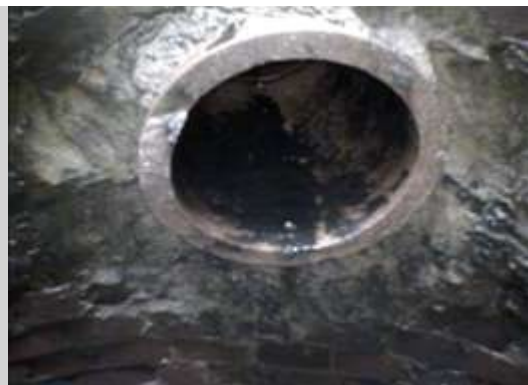
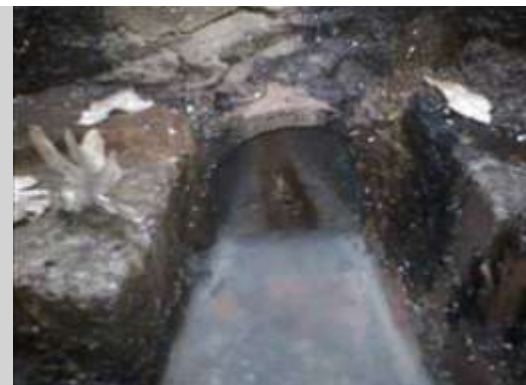
7 O'Clock Inflow

8 in. Circular Gravity Sewer

Infiltration: **None** Pipe Seal Cond: **Sound**

Drop: **Outside** Rod and Bar

Drop Condition: **Open**
